Manhole Inspection Summary

Manhole # S45K__033MH

Location Address: **side 1810 fleet st**

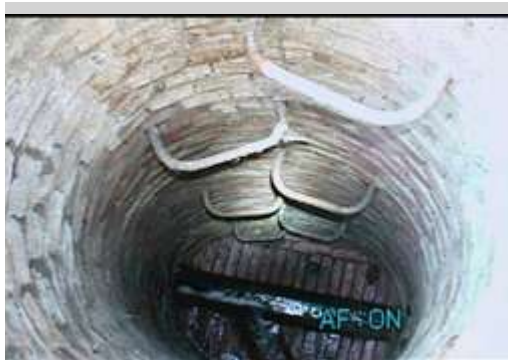
Defect 3

Count: **6** Missing: **1** ☒ **Corroded**

missing/corroded steps

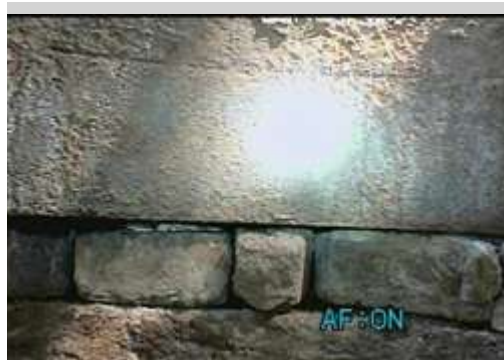
Defect 2

Condition: ☐ Sound ☒ **Cracked** ☐ Root Intrusion ☒ **Loose Brick** ☐ Deteriorated

cracked chimney loose bricks frame adj

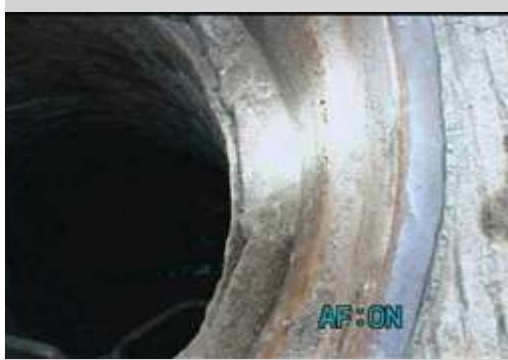
Defect 1

Offset: **2** (in.)

Frame offset
